# Manhole Inspection Summary

Manhole # S31K\_\_003MH

Insp Date: **12/23/08 9:18 AM**

**Location** Address: **Russel St**

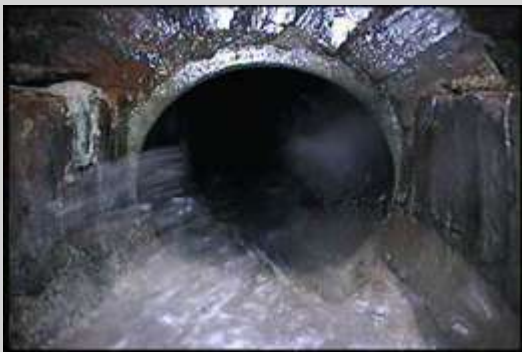
12 O'Clock Outflow

Pipe Height: **12** (in.) Rod and Bar (Angled)  
Pipe Material: **Clay** ☐ Pipe Lined  
Invert Depth: **15.23** (ft.) Flow Characteristics: **Fast**  
Deposits: ☒ None ☐ Mud ☐ Sludge ☐ Debris ☐ Grease  
Silt Depth: **0** (in.) Deposits Extent:  
Infiltration: **None** Pipe Seal Cond: **Sound**

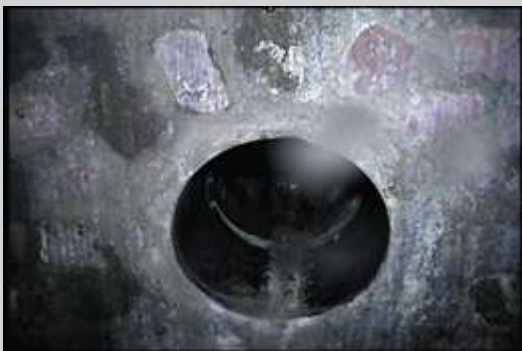
3 O'Clock Inflow

Pipe Height: **8.4** (in.) Rod and Bar (Angled)  
Pipe Material: **Clay** ☐ Pipe Lined  
Invert Depth: **12.31** (ft.) Flow Characteristics: **Slow**  
Deposits: ☒ None ☐ Mud ☐ Sludge ☐ Debris ☐ Grease  
Silt Depth: **0** (in.) Deposits Extent:  
Infiltration: **None** Pipe Seal Cond: **Sound**

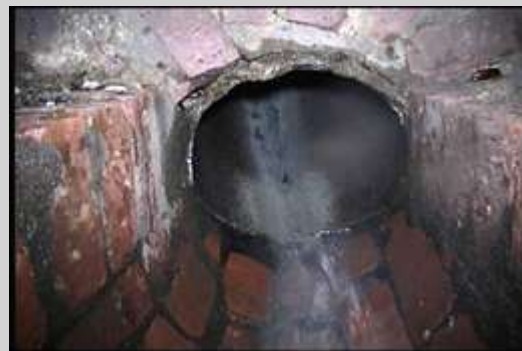
Drop In @ 3 O'Clock

Drop: **Outside** Rod and Bar  
Angled: **Yes** Reading: **13.96** (ft.)  
Inv Depth: **14.96** (ft.)  
Drop Condition: **Open**

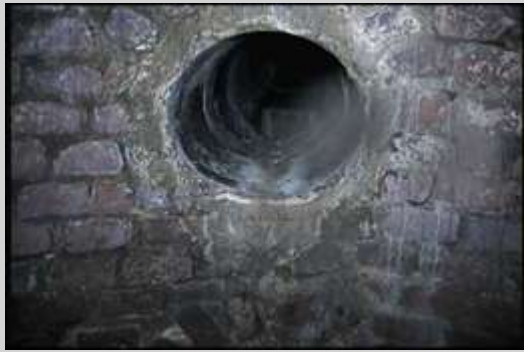
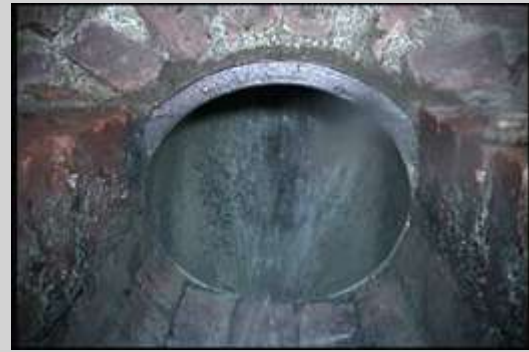
6 O'Clock Inflow

Pipe Height: **12** (in.) Rod and Bar (Angled)

Infiltration: **None** Pipe Seal Cond: **Sound**

Drop Condition: **Open**
